THE SECRETARY  
OF THE INTERIOR'S  
**STANDARDS** FOR  
THE TREATMENT  
OF HISTORIC  
PROPERTIES

WITH  
**GUIDELINES** FOR  
PRESERVING,  
REHABILITATING,  
RESTORING &  
RECONSTRUCTING  
HISTORIC  
BUILDINGS

U.S. Department of the Interior  
National Park Service  
Technical Preservation Services

2017

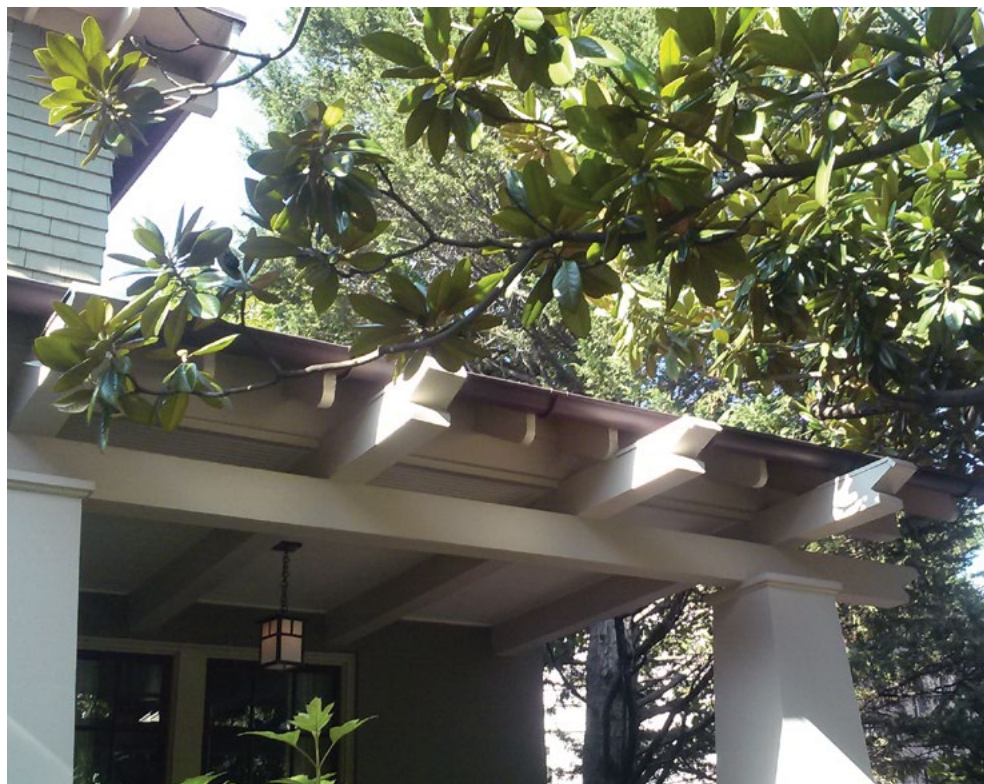
[12] Repair and limited replacement in kind to match deteriorated wood porch features is always a recommended preservation treatment.
